HOW-TO: repairing ABS unit (VW part nr. 8E0 614 111B) on VW Passat B5

Автор pavel. translate vadmore and Lucky3D

09.12.2005 г.

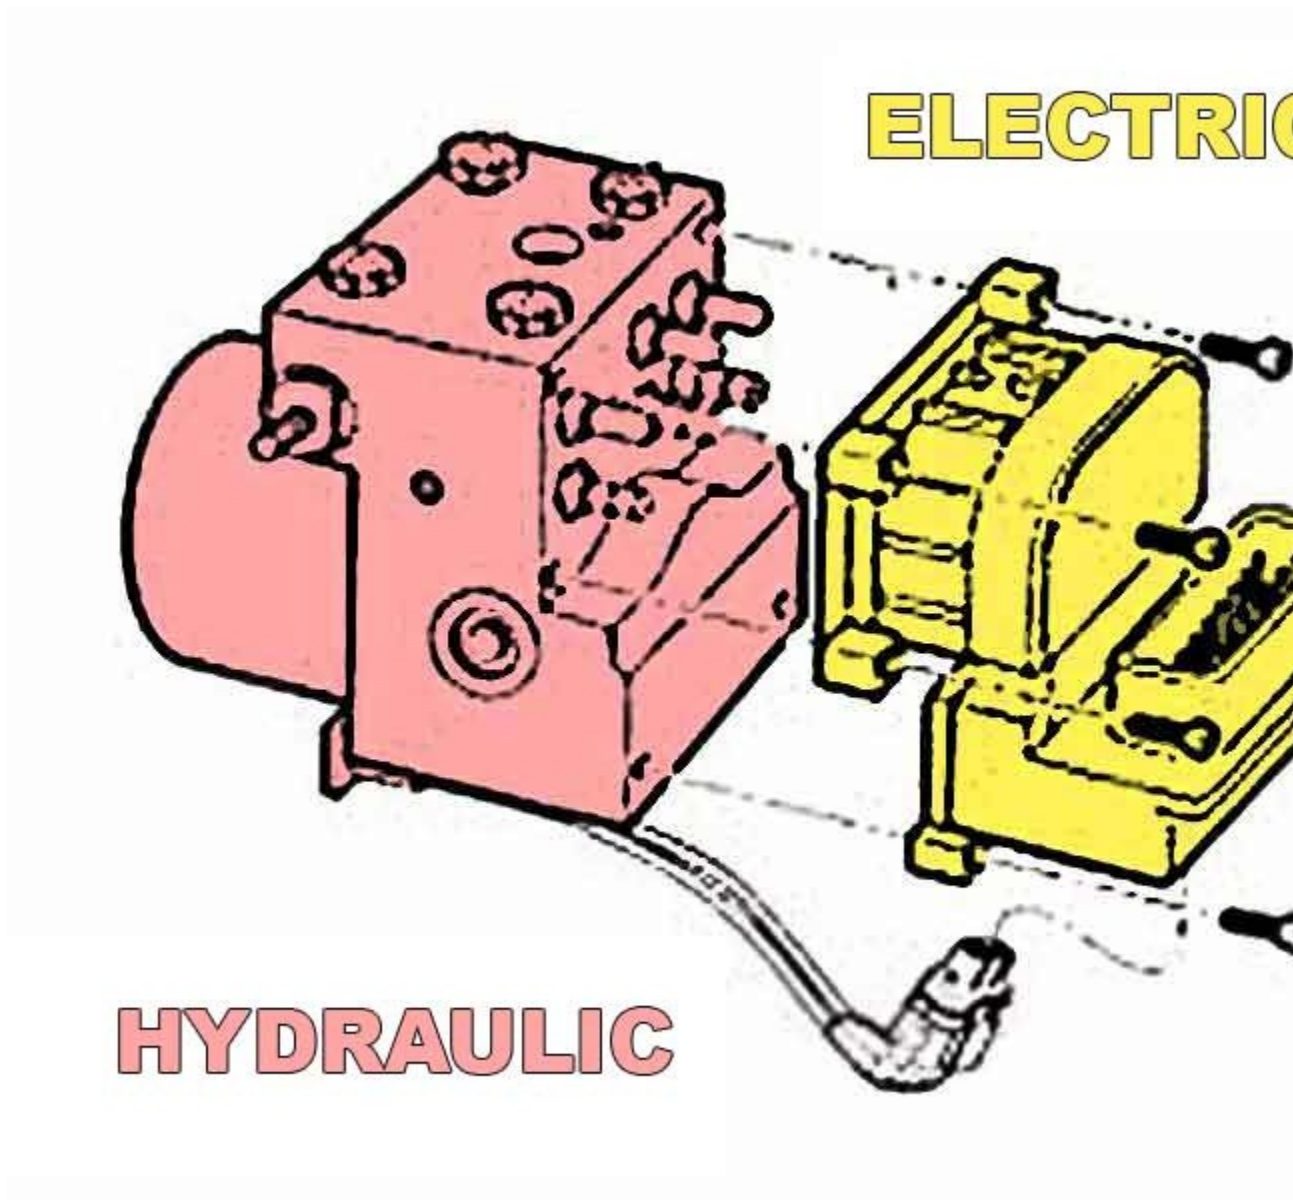
ABS unit consists of two parts: hydraulic and electrical control unit.

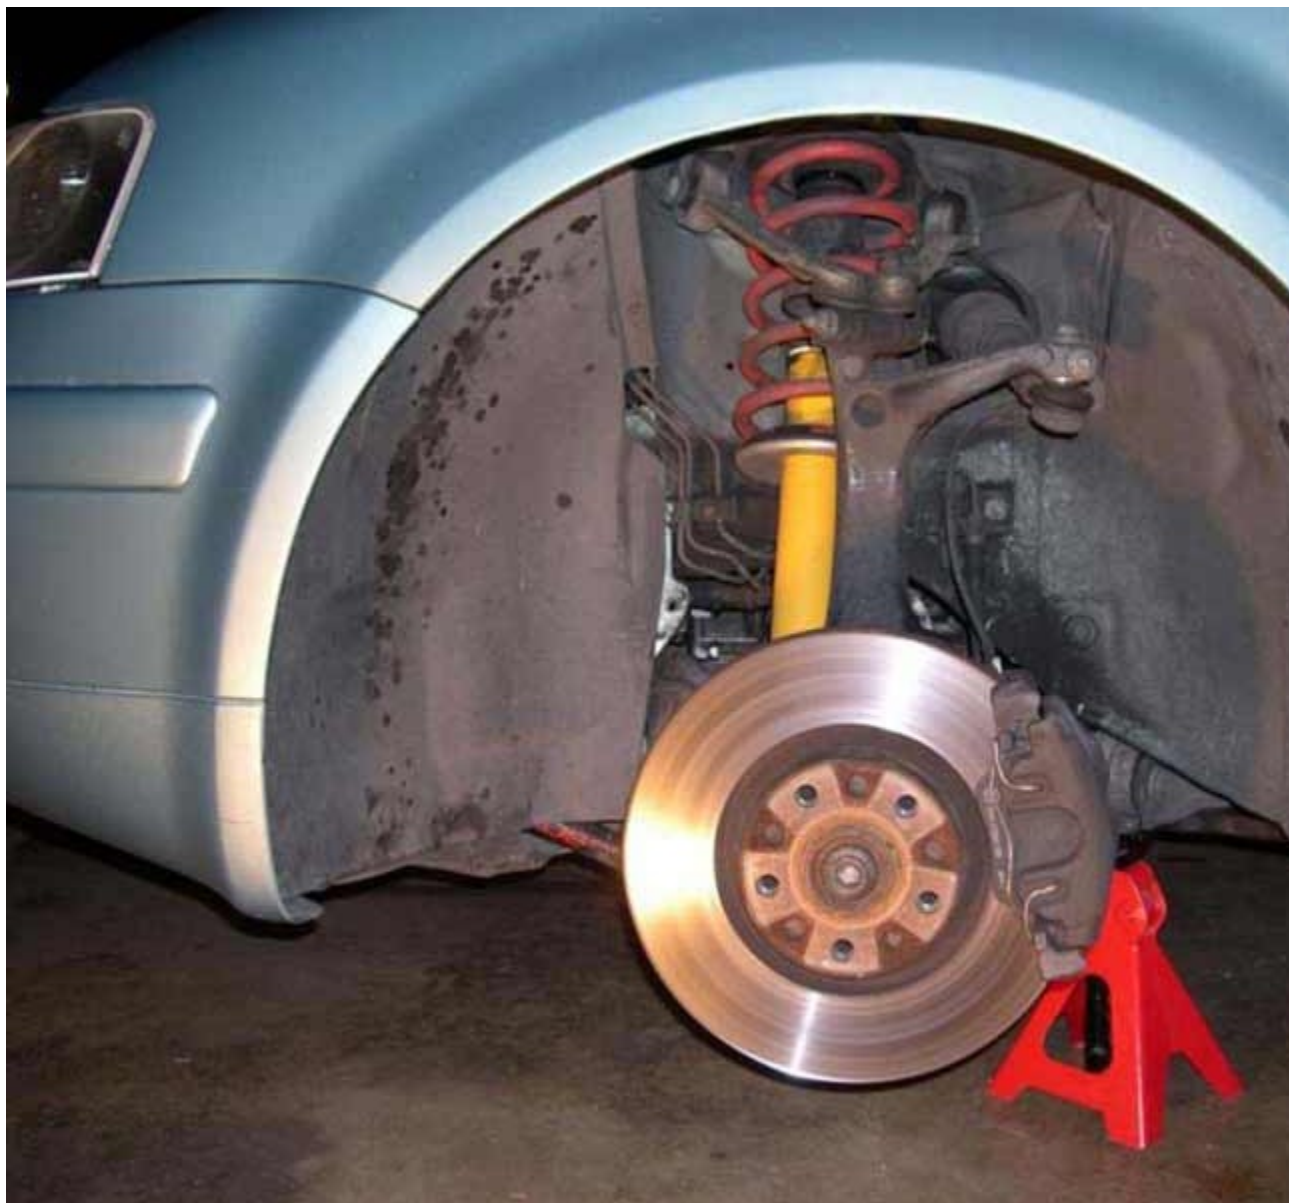
Lift up left wheel and take it off. Consider using jack stand, cause you will need to spend some t

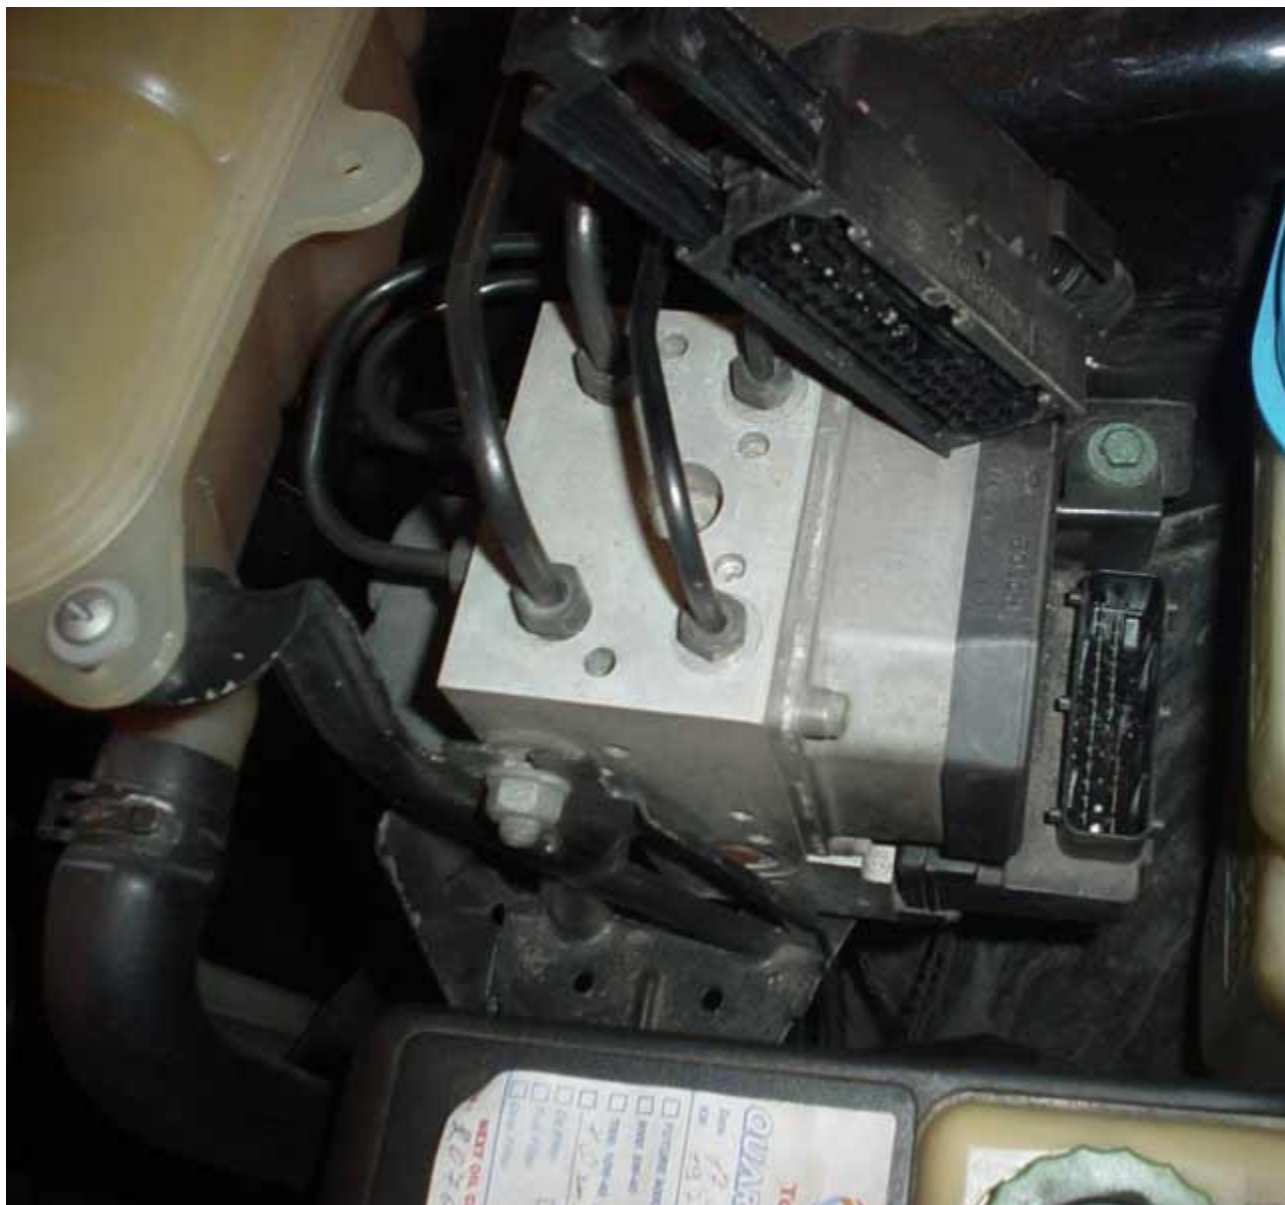
Remove the fenderliner, by unscrewing 11 TORX bolts.
Unscrew the fluid container for windshield washer (2 bolts behind the fenderliner and 1 is under
Push it slightly to the left to gain access to the ABS unit.
Remove the connector from the electrical part:

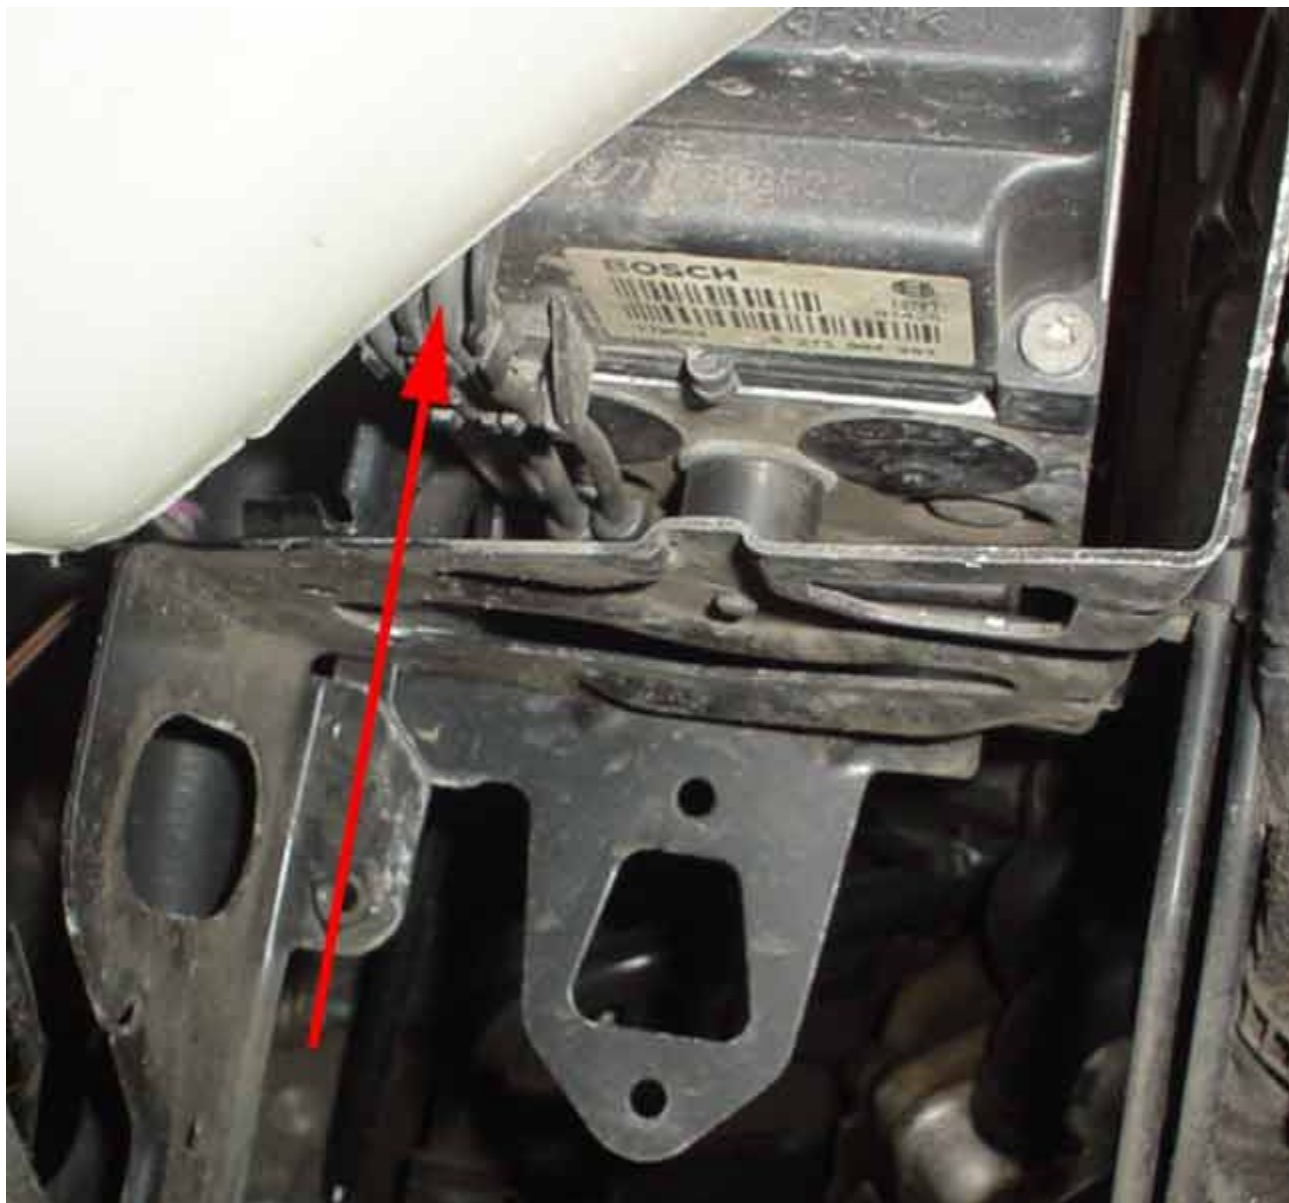
Remove the connector from hydraulic pump (under the electrical part).

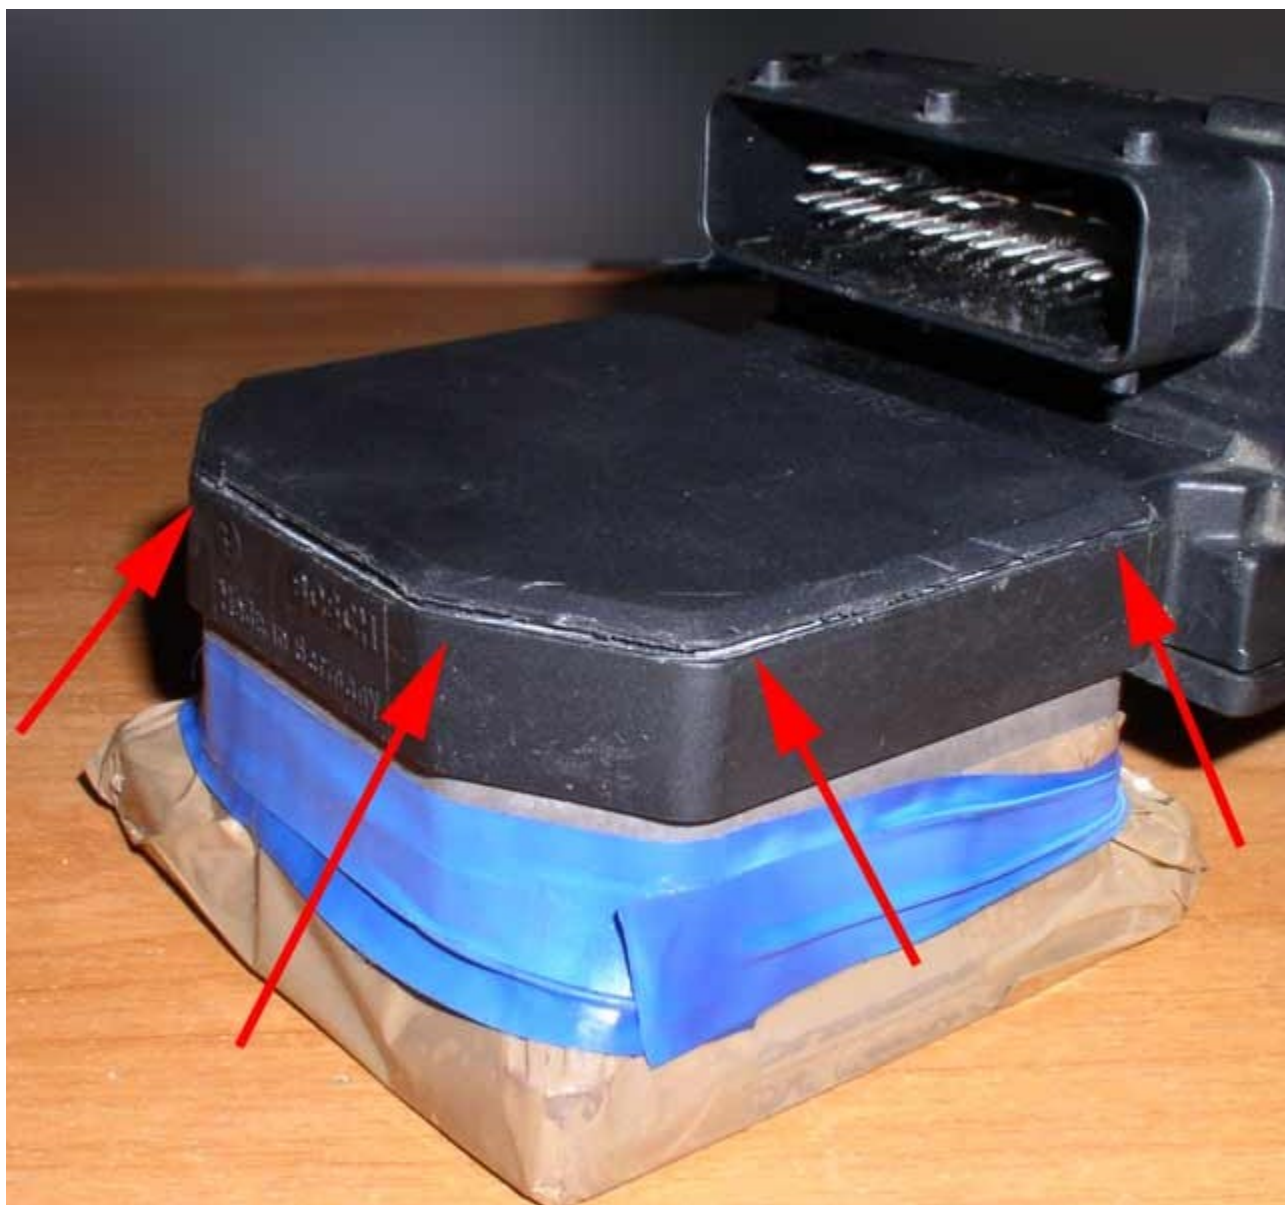
Now you need to cut off the upper plastic cap.

You can use a sharp knife or any similar tool just to cut a bit along the accessible sides.

Do not use excessive force or you can end up with the knife ruining electrical parts on board.

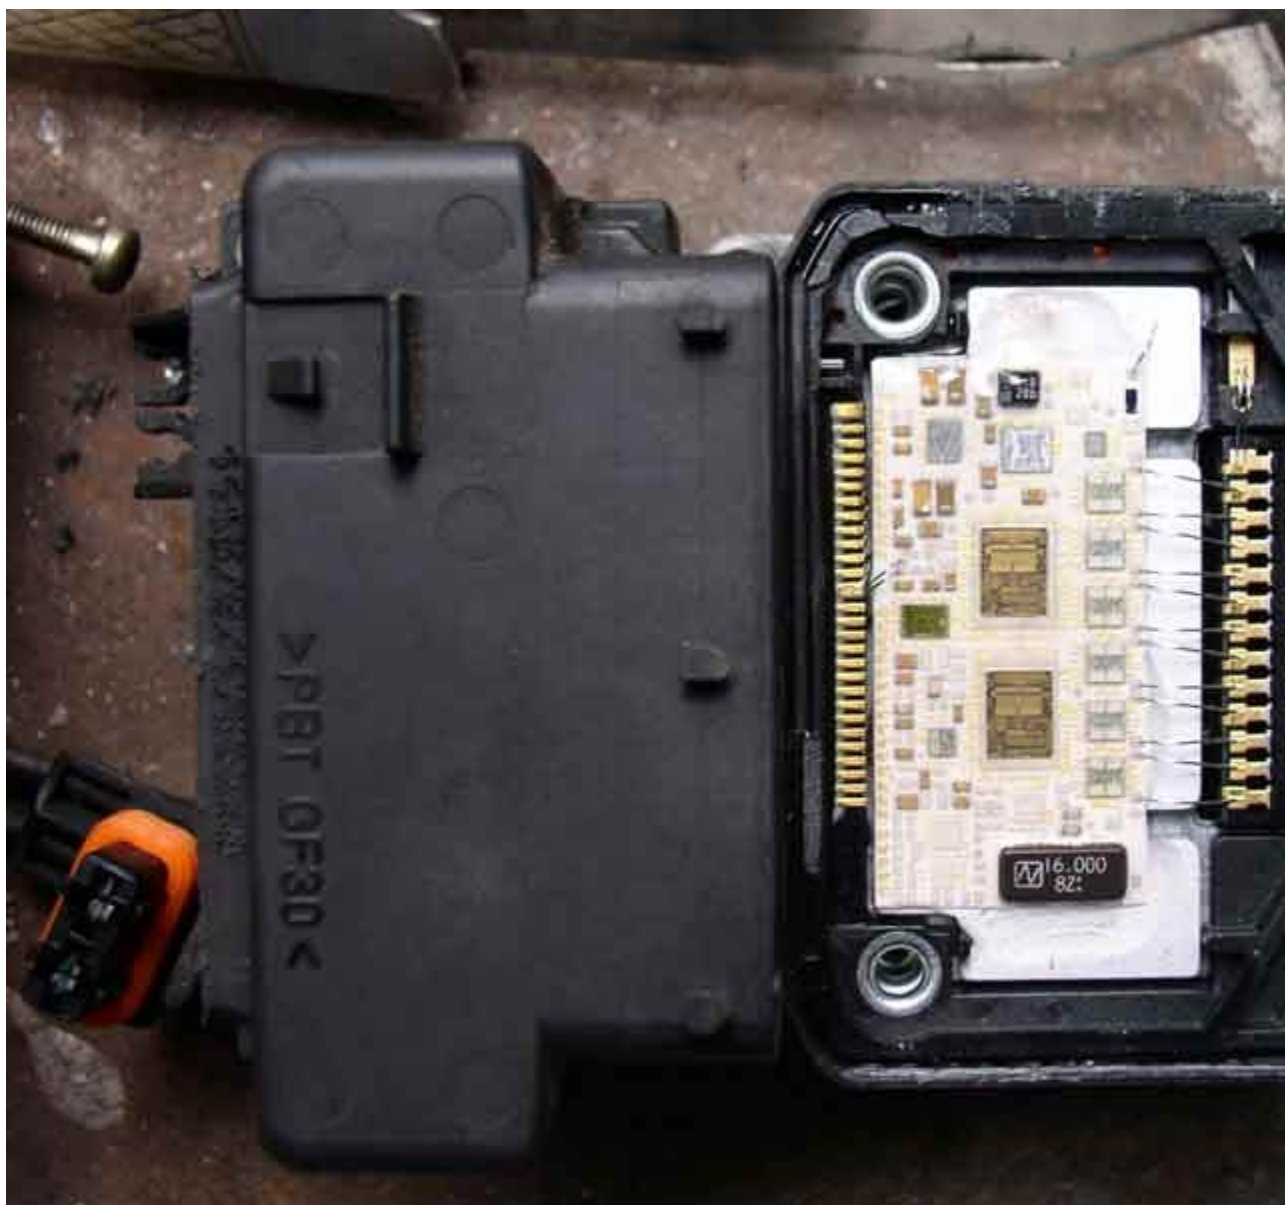
Now you will see a ceramic board with a plenty of electrical components covered with some gel-

DO NOT touch it or you will completely damage the unit.

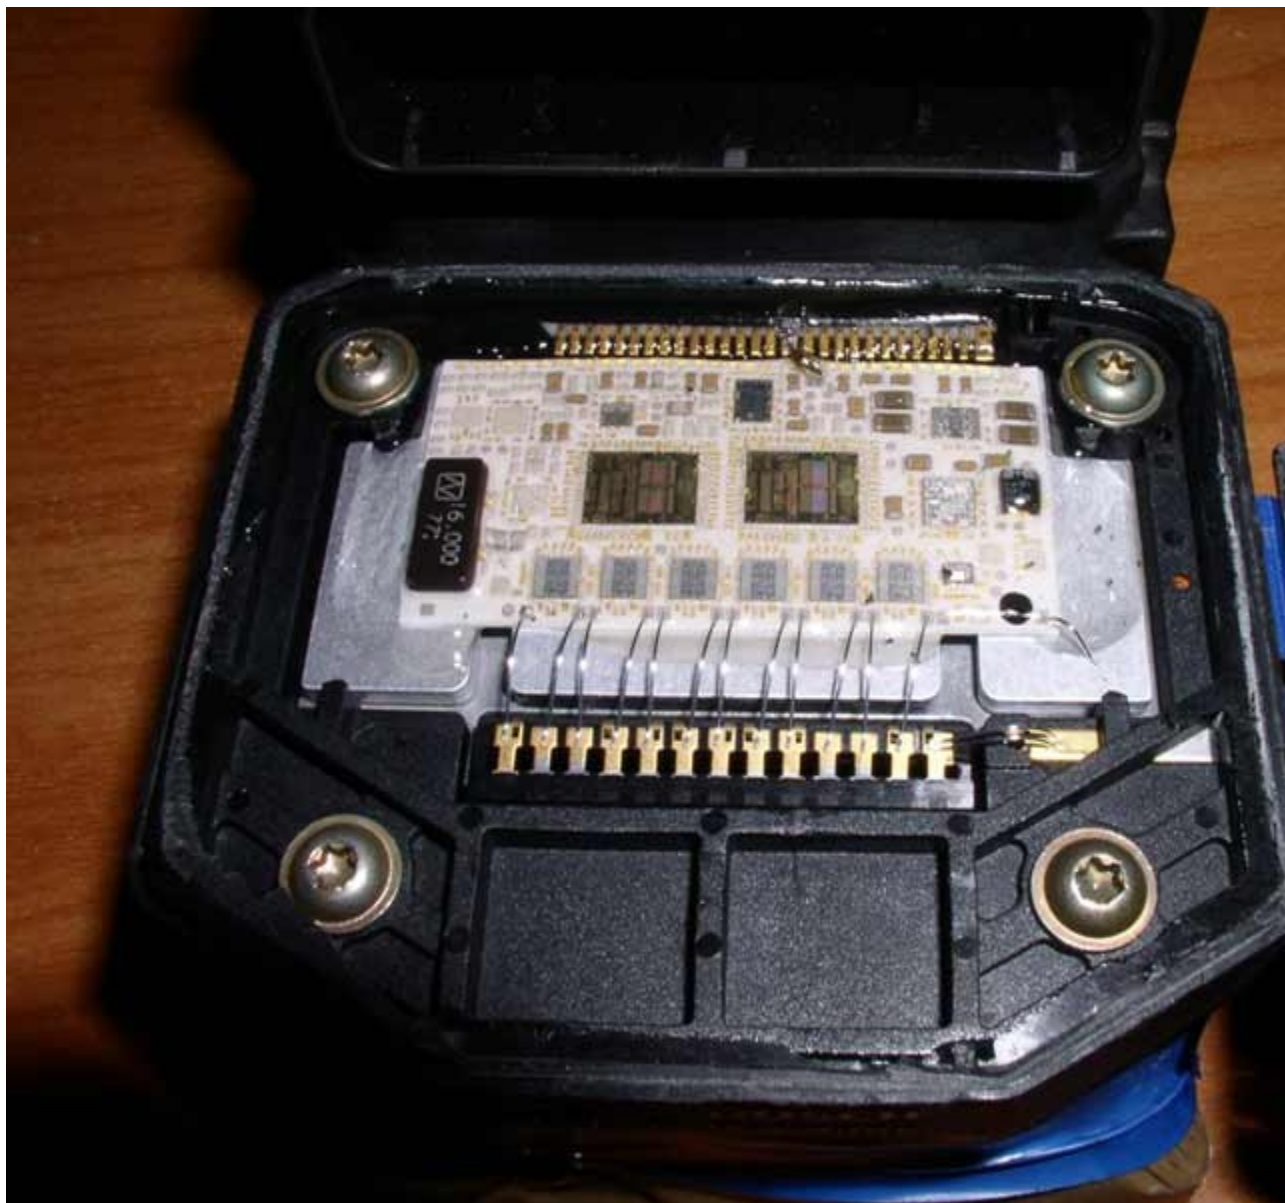
Dimensions of the box that has been opened are 70 by 83 mm.

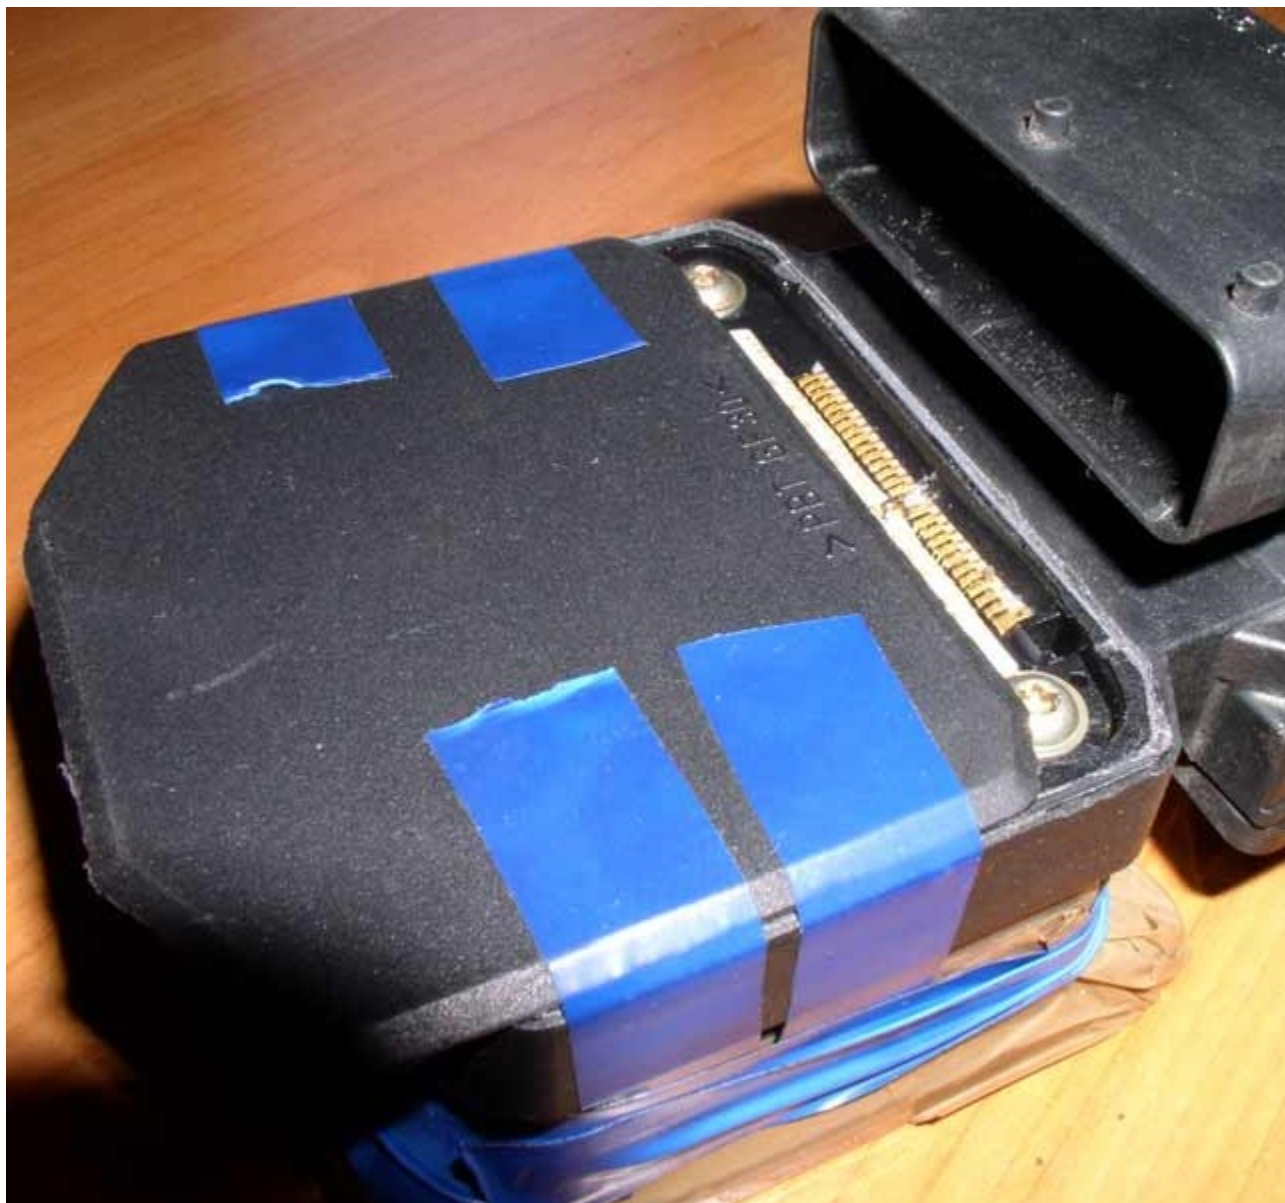
Now close the electrical board, so you can only access place where board is connected to the coil electrical unit case.
Secure it with adhesive tape. Now you can be sure that you won't touch the board accidentally.

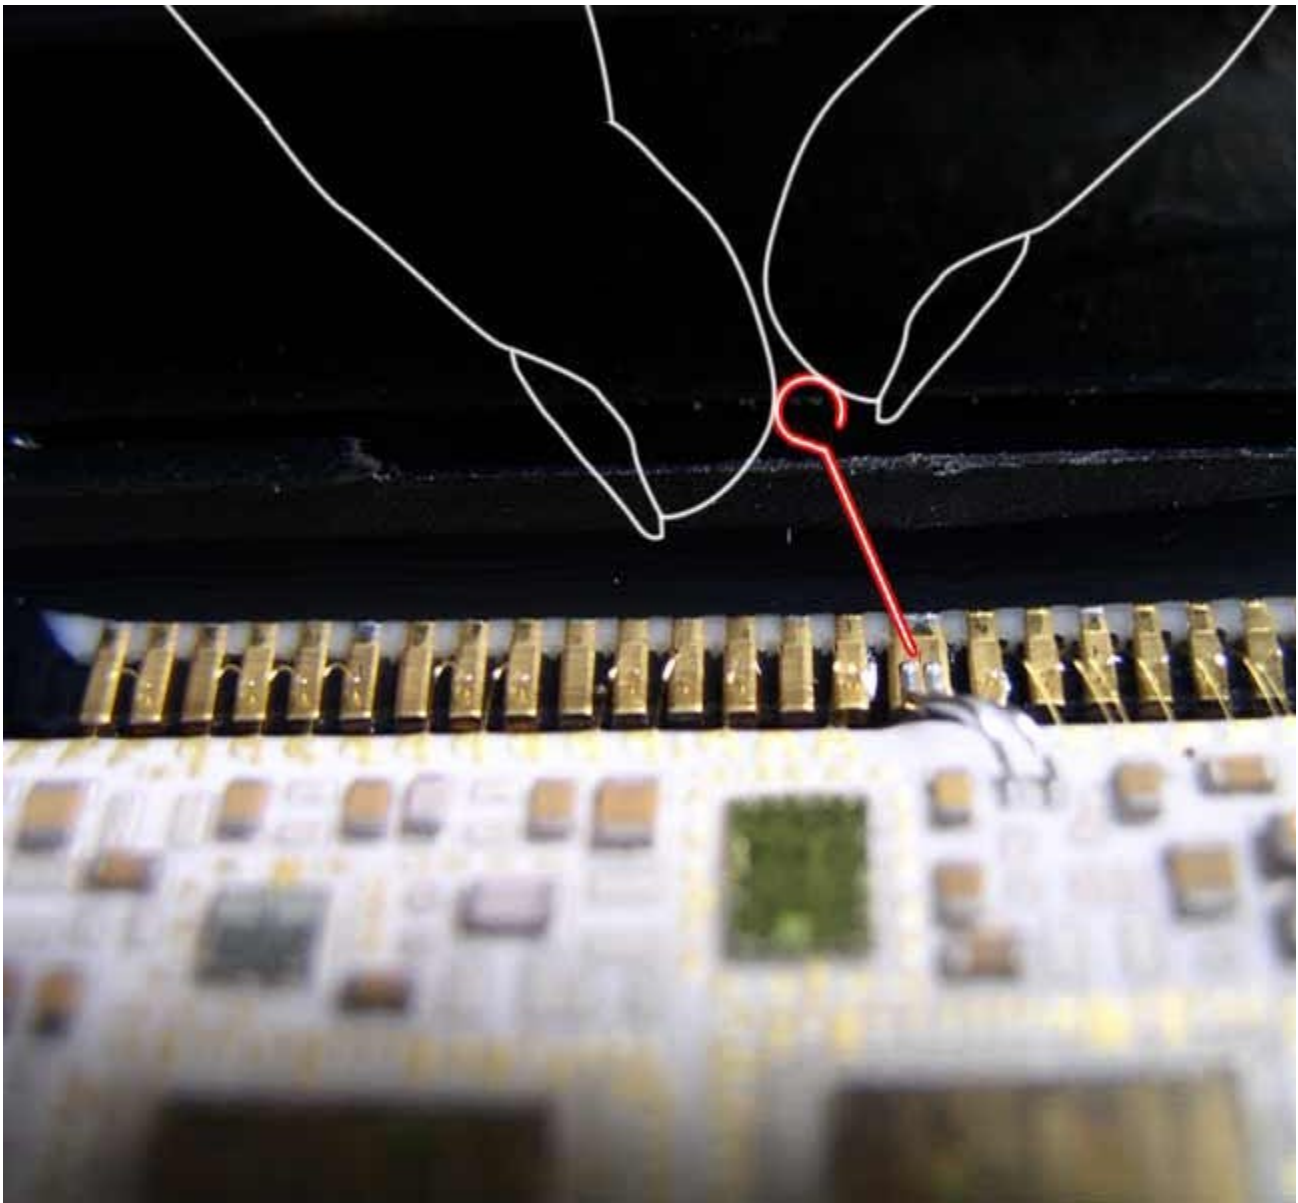
Find the place where board is connected to the contact plates by two wires.
Take a needle and try to slightly push the wires.
Gotcha! The contact between these two wires and contact plates is loose.

This is the problem of these ABS units.
Now your task is to carefully remove gel-like substance from contact plates.
Use any suitable tool like toothpick.
Do it with great care! There are very thin wires all around, you can easily tear them.

Tin the contact plate and solder long (10 cm) and thin (ca 0.3 mm) wire to it.
Tin the silver conductors at the place of their maximum distance from the board.
Place copper wire between the silver conductors and solder them all together.
This will provide heat dislocation from the contact plate and hopefully will solve a problem of un:
Cut the remaining part of copper wire.
